# Maryland Historical Trust Maryland Inventory of Historic Properties number: 280

MHT No. <u>BA-2847</u>

MARYLAND INVENTORY OF HISTORIC BRIDGES HISTORIC BRIDGE INVENTORY MARYLAND STATE HIGHWAY ADMINISTRATION/MARYLAND HISTORICAL TRUST

SHA Bridge No. B0065 Bridge name Mt. Zion Road over Piney Run	
LOCATION: Street/Road name and number Mt. Zion Road	
City/town Arcadia Vicinity X	
County Baltimore	
This bridge projects over: Road Railway Water X Land	
Ownership: State County X Municipal Other	
HISTORIC STATUS:  Is bridge located within a designated historic district? Yes No _X  National Register-listed district National Register-determined-eligible district  Locally-designated district Other	
Name of district	
BRIDGE TYPE: Timber Bridge: Beam Bridge Truss -Covered Trestle Timber-And-Concret  Stone Arch Bridge	e
Metal Truss Bridge	
Movable Bridge: Swing Bascule Single Leaf Bascule Multiple Leaf Vertical Lift Retractile Pontoon	_
Metal Girder: Rolled Girder: Rolled Girder Concrete Encased Plate Girder Plate Girder Concrete Encased	
Metal Suspension	
Metal Arch	
Metal Cantilever	
Concrete X:  Concrete Arch_X Concrete Slab Concrete Beam Rigid Frame

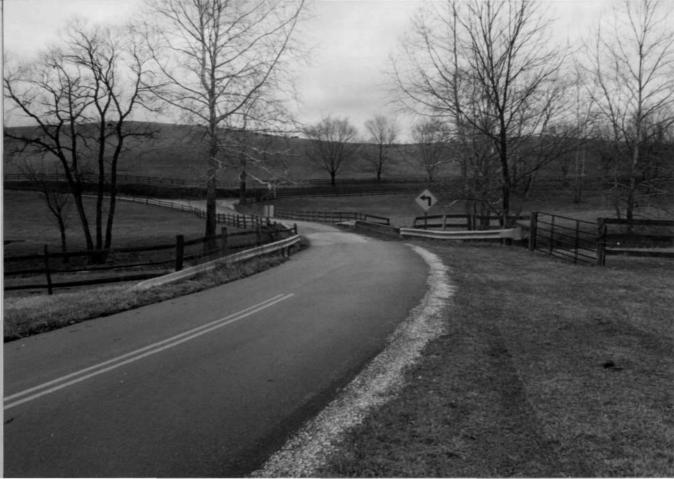
Inventory	#	BA-2847

Name BUDG MOUNT County/State BALTIN	LION RD O	VER PINEY RUN
Name of Photographer Date 195		
ocation of Negative _	SHA	
S	APPROACH	LOOKING NOTH

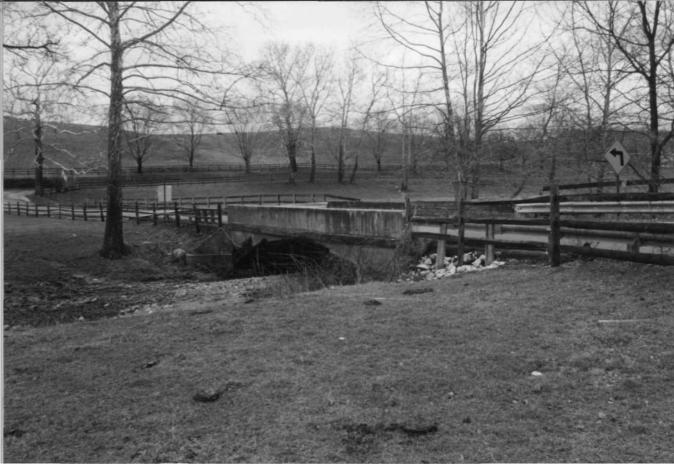
### Inventory # <u>B4-2847</u>

ounty/Stat	6-MOUNT ZION RD OVER PINEY RUN TO BALTIMORE COUNTY IMD
Jame of Ph	notographer DAVE DIEHL
Date 1/99	5
V	
ocation of	Negative 5HA
	INCO CIENNATION INDUING
escription	NURTH EAST

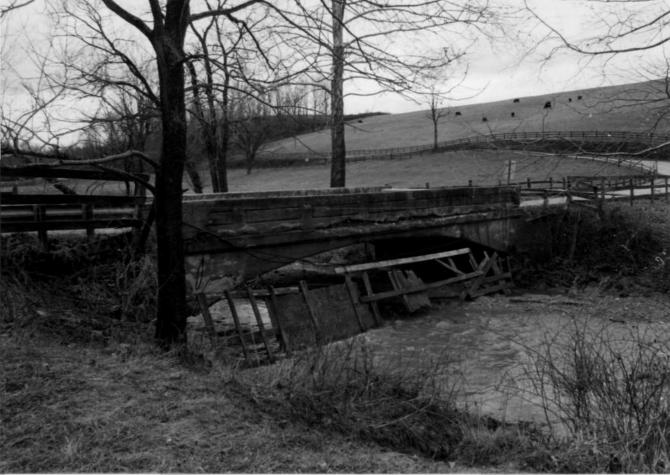
## Inventory # <u>BA-2847</u>

Name Book 5	- WOUNT ZION RO WER PINEY RUN
County/State	BALTIMORE COUNTY IND
	tographer DAVE MEHL
Date 1195	
Location of M	Negative 5NA
Description	NORTHWEST
10 S 2 S 2 S 2 S 2 S 2 S 2 S 2 S 2 S 2 S	NORTHWEST
	STATE OF THE PARTY
Number 25	of 394
